# PK-USA PKI Series I-joists

## Minor Flange Cuts and Banding Damage

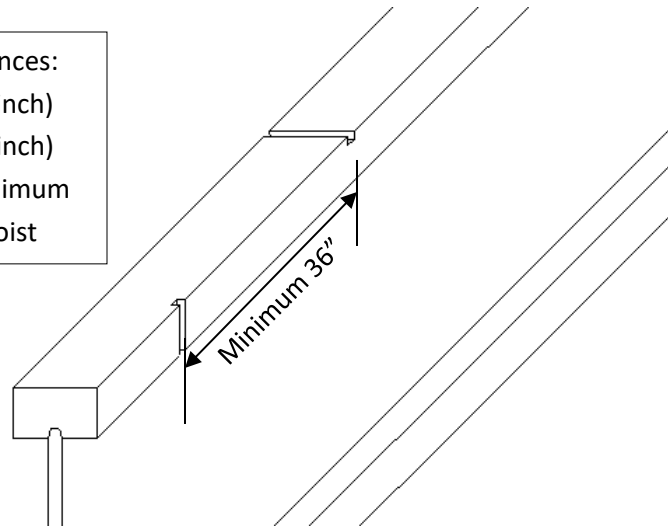
When handling, cutting and packaging PKI Series I-joists, it is common for small cuts to be mistakenly made to the joist flanges. These cuts can be as the result of a chainsaw blade bump to the top of the joist pack or a skill-saw cut with the depth guard improperly set. While these small cuts are unsightly, they do not affect the performance of the joist provided they fall within the following limitations:

Maximum allowable distances:

- Depth =  $\frac{1}{4}$ " (0.25-inch)
- Width =  $\frac{1}{4}$ " (0.25-inch)
- Spacing = 36" Minimum
- Quantity = 2 per joist

**Note: If minor flange cuts or banding damage exceed those listed above, a review from a licensed design professional may be required.**

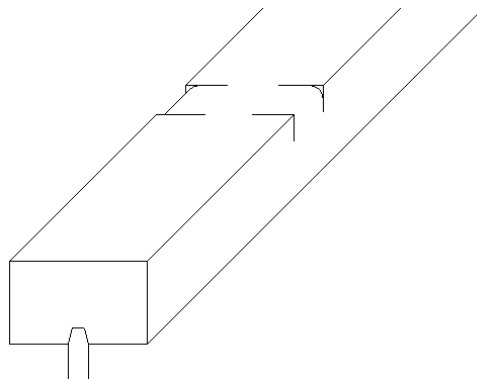
Crushing damage can occur when joist pack banding is cinched too tightly around the I-joist. This is particularly true when the joist has been exposed to wet weather conditions prior to or during the banding process. The appearance of banding marks and flange distortions, as seen below, does not affect the performance of the joist.
