## Pinkwood PKjoists® Minor Flange Splits at Bearing

**TECHNICAL BULLETIN**  
**TB23**

January 2026

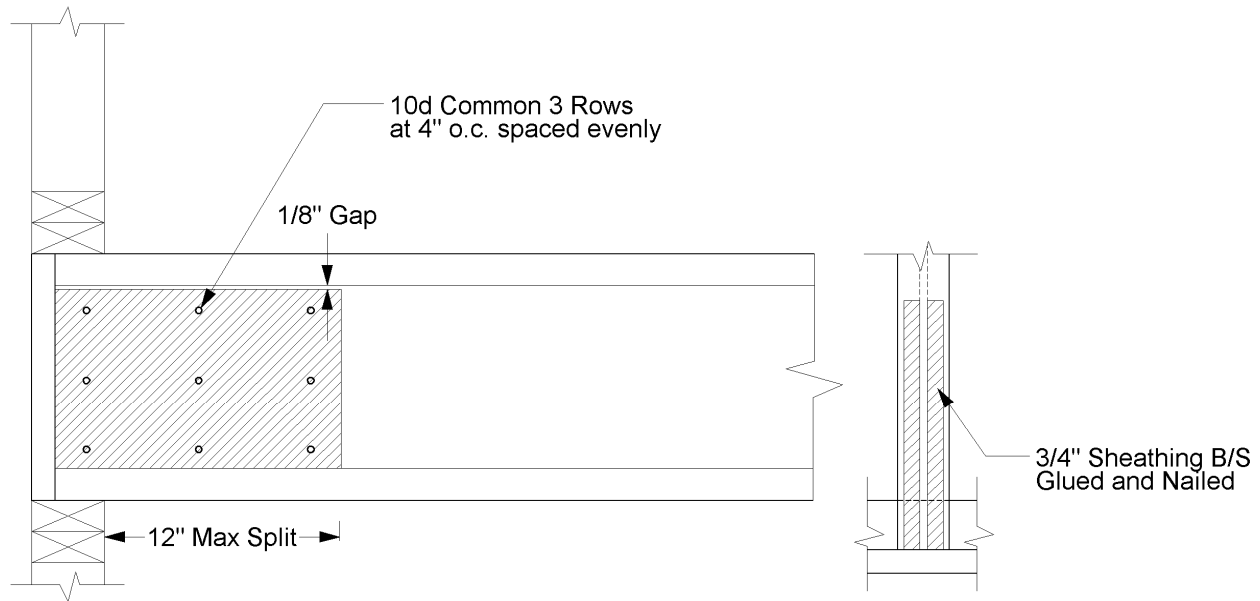
When installing PKjoists®, it is common for small splits to occur in the bottom flange at the bearing location. This is often due to toenails intersecting each other when the bottom flange is secured to the plate. To eliminate excessive reaction forces at the joist web, stiffeners can be used to widen the reaction area.

1. End Bearing Split cannot exceed 12" in length beyond the inside face of bearing.
2. The split cannot exceed 0.25" (1/4") in wide.
3. The effected joist does NOT require a web stiffener under normal conditions.
4. Sheathing can be either OSB or CDX plywood.
5. Installed stiffener must be a minimum 16" long and flush to the end of the joist.
6. Use subfloor adhesive between stiffener and joist web.

***Note: If minor flange splits exceed those listed above, a review from a licensed design professional may be required.***
