## Pinkwood PKjoists® Minor Bottom Flange Splits at Mid-Span

**TECHNICAL BULLETIN**  
**TB24**  
January 2026

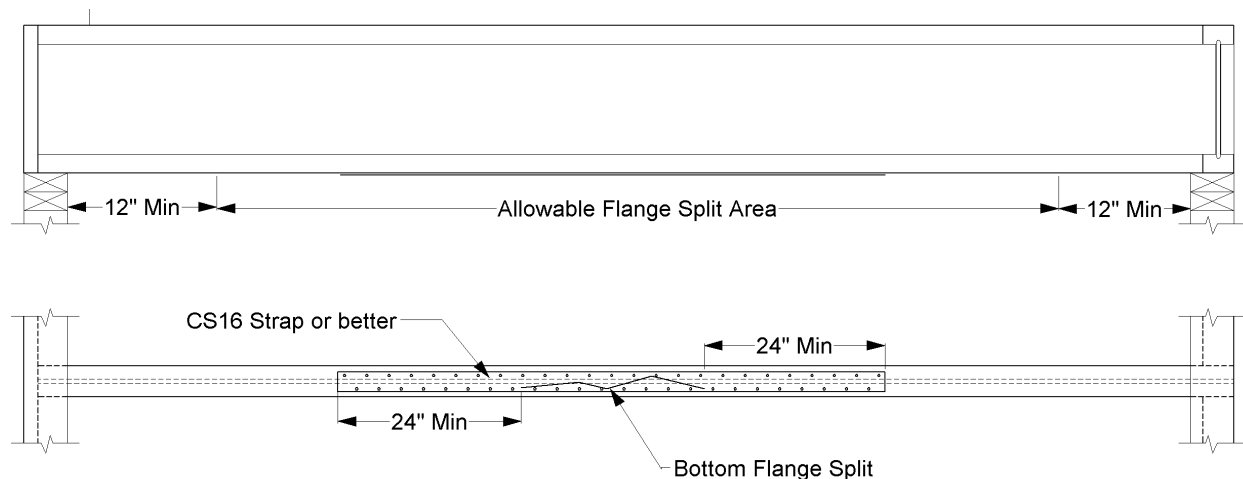
When handling and storing PKjoists®, it is common for small splits and checks to occur in the solid sawn flange material. This is often due to additional drying of the flange material after manufacturing. When minor splits occur in the top flange, subfloor adhesive and fastener connections are sufficient to remedy the condition. When minor splits occur in the bottom flange, a standard construction strap is sufficient to transfer the tension past the minor split and into unaffected sections of the flange. When needed, construction strapping should be installed as listed below.

1. Bottom Flange Split cannot exceed 24" in length.
2. The split cannot exceed 0.25" (1/4") in width.
3. The Tension strap must extend 24" beyond the end of the split on both ends.
4. Use 8d nails to attach the Tension strap and fill all holes.
