# PK-USA PKI Series I-joists

## Minor Bottom Flange Splits at Mid-Span

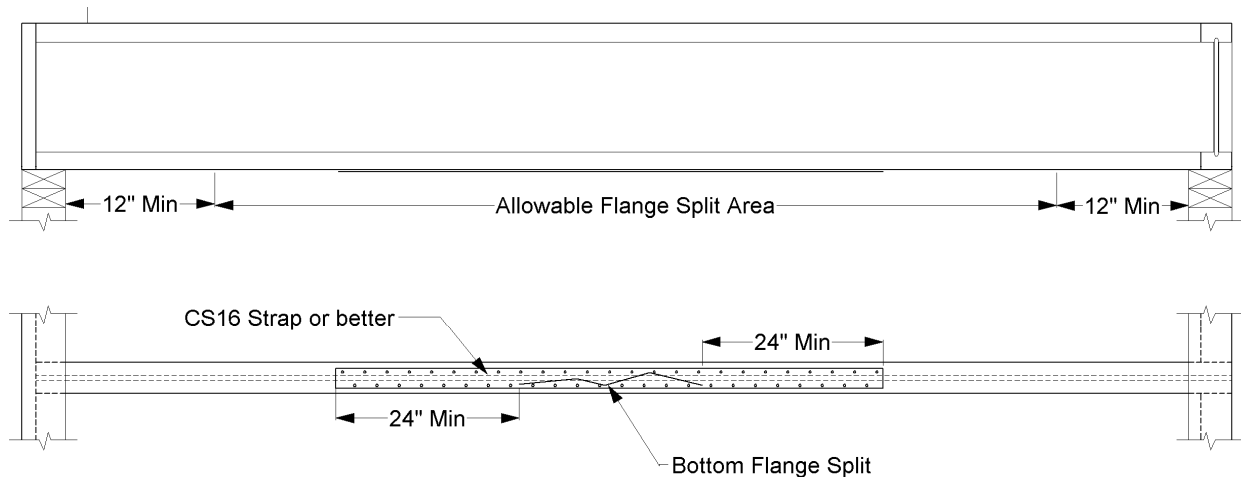
When handling and storing PKI Series I-joists, it is common for small splits and checks to occur in the solid-sawn flange material. This is often due to additional drying of the flange material after manufacturing. When minor splits occur in the top flange, sub-floor adhesive and fastener connections are sufficient remedy the condition. When minor splits occur in the bottom flange, a standard construction strap is sufficient to transfer the tension past the minor split and into unaffected sections of the flange. When needed, construction strapping should be installed as listed below.

1. Bottom Flange Split cannot exceed 24" in length.
2. The split cannot exceed 0.25" (1/4") in width.
3. The Tension strap must extend 24" beyond the end of the split on both ends.
4. Use 8d nails to attach the Tension strap and fill all holes.

**Note: If minor flange splits exceed those listed above, a review from a licensed design professional may be required.**
