# PK-USA PKI Series I-joists

## Standard Top Flange Notch Repair

### Flange notch repair

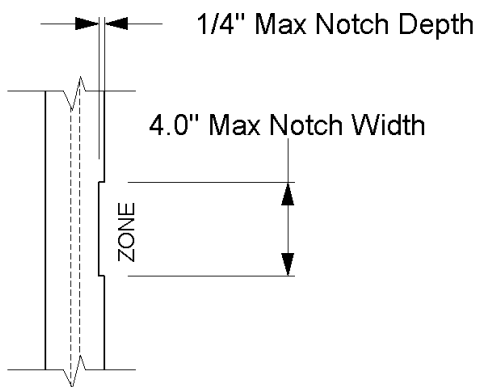
#### Notch Dimensions

While It is common for sub-floor penetrations to occur close to joist locations, it is recommended, when possible, to shift the joist away from such penetration to avoid inadvertent cutting the joist top flange. (see **TB02** *On-Center shift allowance for plumbing*) When this is not possible, or when the joist shift was missed during construction, minor top flange notches on uniformly loaded joists can be repaired in a standardized method provided the location, size and length of these notches are as indicted below.

1. Use minimum 2x4 #2 Grade or better.
2. Apply construction adhesive to entire contact surface of reinforcement.
3. Install reinforcement tight to the underside of the top flange opposite the side of the notch.
4. Attach with min 10d common, 2 rows, staggered and clinched @ 6" o.c. or #8 wood screws.

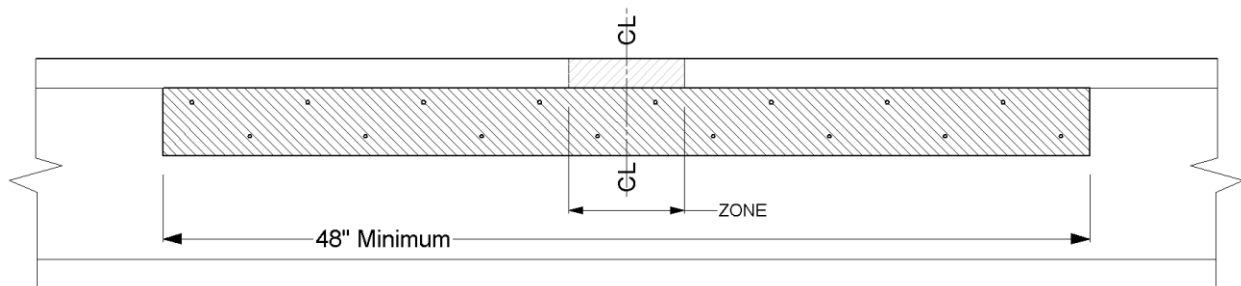
#### Repair Location

OPPOSITE SIDE OF NOTCH
