## Pinkwood PKjoists® Multiple Bearing Uplift Conditions

**TECHNICAL BULLETIN**  
**TB22**  
January 2026

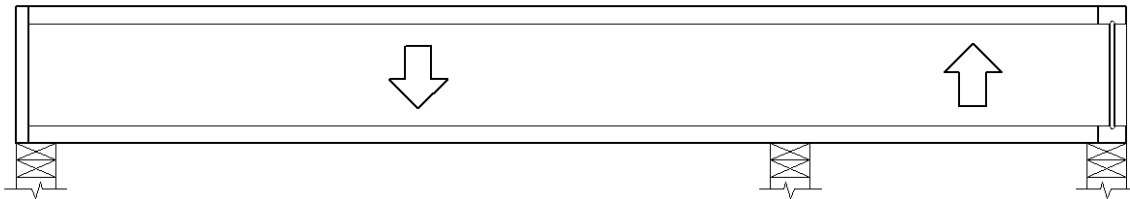
When designing floor and roof systems utilizing PKjoist® it is necessary to have sufficient bearing locations to support the joist span and loads. For conditions in which multiple bearing supports are used within a given span, the location of those bearing can cause an “uplift” condition in the joist. This typically occurs when the distance between bearing support is uneven. As the span differences between bearing supports grow, the amount of uplift in the shorter span increases. Large point loads within a given span can also induce an “uplift” condition when the point load only occurs in one of the span sections.

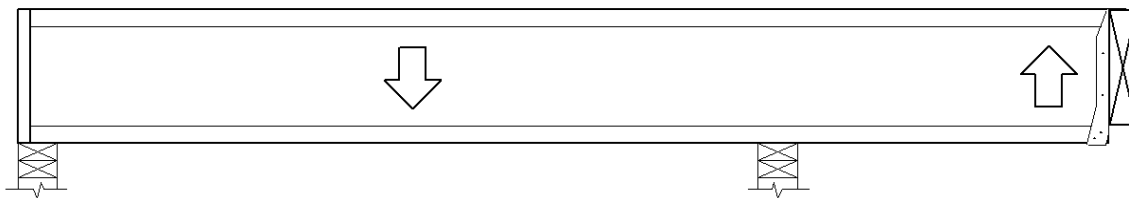
When the joist design of a multiple bearing condition PKjoist® occurs, the failure is typically attributed to the joist exceeding its maximum reaction capacity or exceeding the maximum allowable shear capacity at bearing. Another source of uplift failure occurs when the joist is being supported by a hanger or other hardware in which the uplift capacity of the hanger is insufficient to contain the uplift forces of the joist. This limitation is typically seen in top flange hangers or hangers with fewer nailing locations into the side of the joist or the support member.
