# PK-USA PKI Series I-joists

## Multiple Bearing Uplift Conditions

# TECHNICAL BULLETIN

## TB24

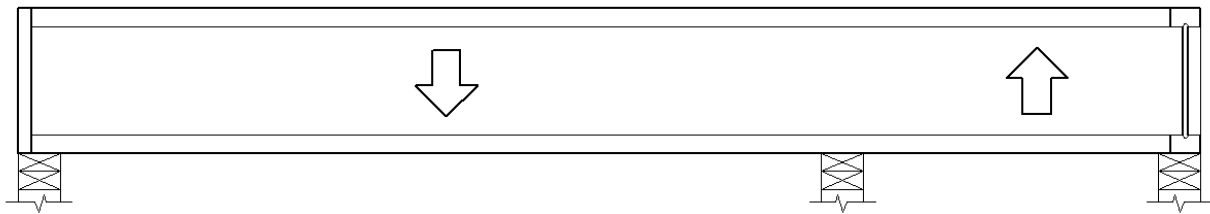
When designing floor and roof systems utilizing PKI Series I-joist it is necessary to have sufficient bearing locations to support the joist span and loads. For conditions in which multiple bearing supports are used within a given span, the location of those bearing can cause an “uplift” condition in the joist. This typically occurs when the distance between bearing support is uneven. As the span differences between bearing supports grow, the amount of uplift in the shorter span increases. Large point loads within a given span can also induce an “uplift” condition when the point load only occurs in one of the span sections.

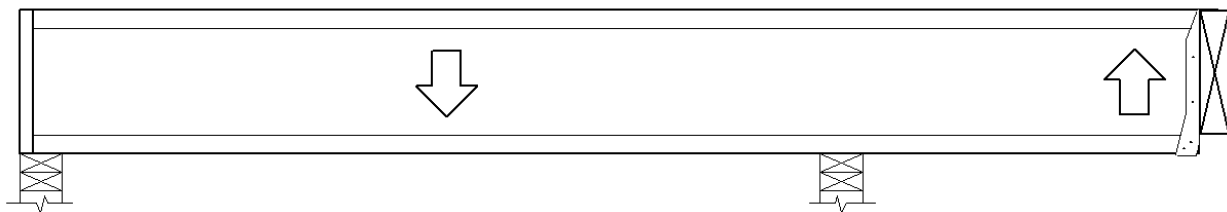
When the joist design of a multiple bearing condition PKI Series I-joist occurs, the failure is typically attributed to the joist exceeding its maximum reaction capacity or exceeding the maximum allowable shear capacity at bearing. Another source of uplift failure occurs when the joist is being supported by a hanger or other hardware in which the uplift capacity of the hanger is insufficient to contain the uplift forces of the joist. This limitation is typically seen in top flange hangers or hangers with fewer nailing locations into the side of the joist or the support member.
